SCAPPOOSE DRAINAGE IMPROVEMENT COMPANY

Operation and Maintenance Manual

Flood Control Works

Adopted Version 1-11-2024

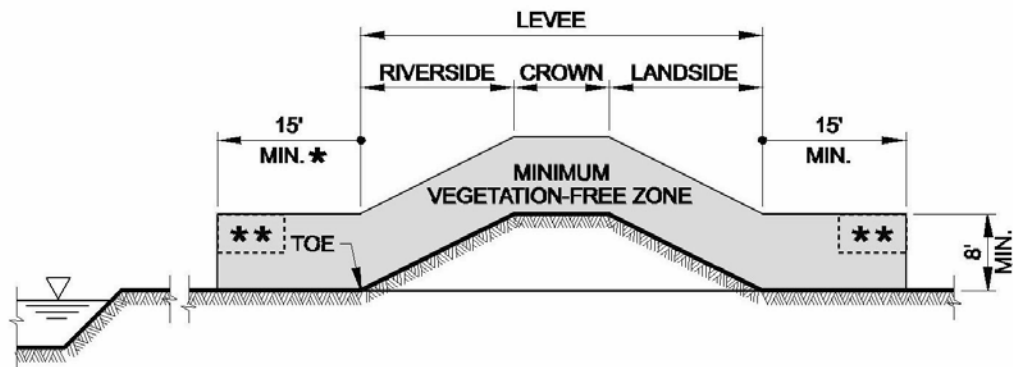
The figures presented here are cross-sections and are organized as follows. Figure 1 illustrates the minimum vegetation-free zone required for a basic levee section.

* 15' OR DISTANCE TO EDGE OF NORMAL WATER SURFACE, IF LESS

** IN THIS 4' X 7' TRANSITION ZONE, TEMPORARY OBSTRUCTION BY LIMBS AND CROWN IS ALLOWED DURING DEVELOPMENT OF NEW PLANTINGS, FOR UP TO 10 YEARS

▽ NORMAL WATER SURFACE

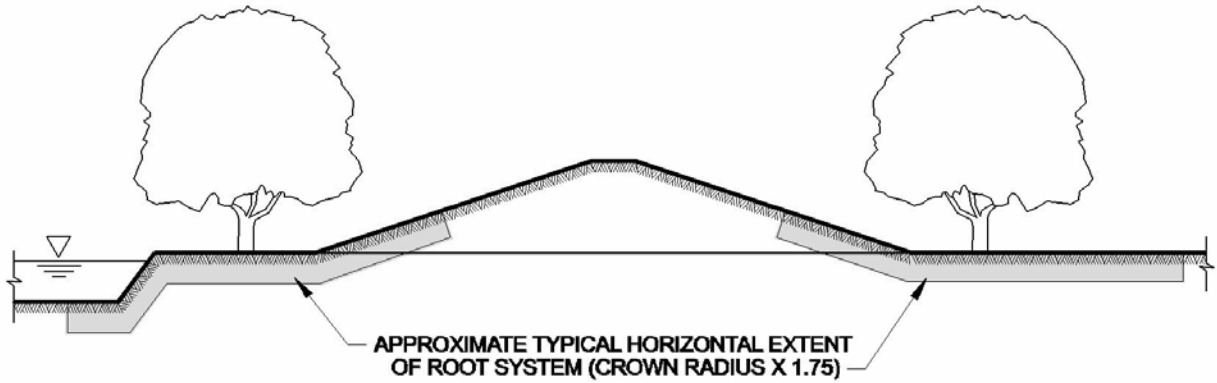
THIS PROPORTIONALLY CORRECT FIGURE USES TREES IN THE MEDIUM TO LARGE SIZE RANGE TO ILLUSTRATE REALISTIC SPATIAL RELATIONSHIPS BETWEEN TREES (AND THEIR ROOT SYSTEMS) AND LEVEES.

a. TREES (50' TALL, 50' SPREAD) LOCATED AT EDGES OF VEGETATION FREE ZONE (TRUNK CENTER AT 15' FROM LEVEE TOE)

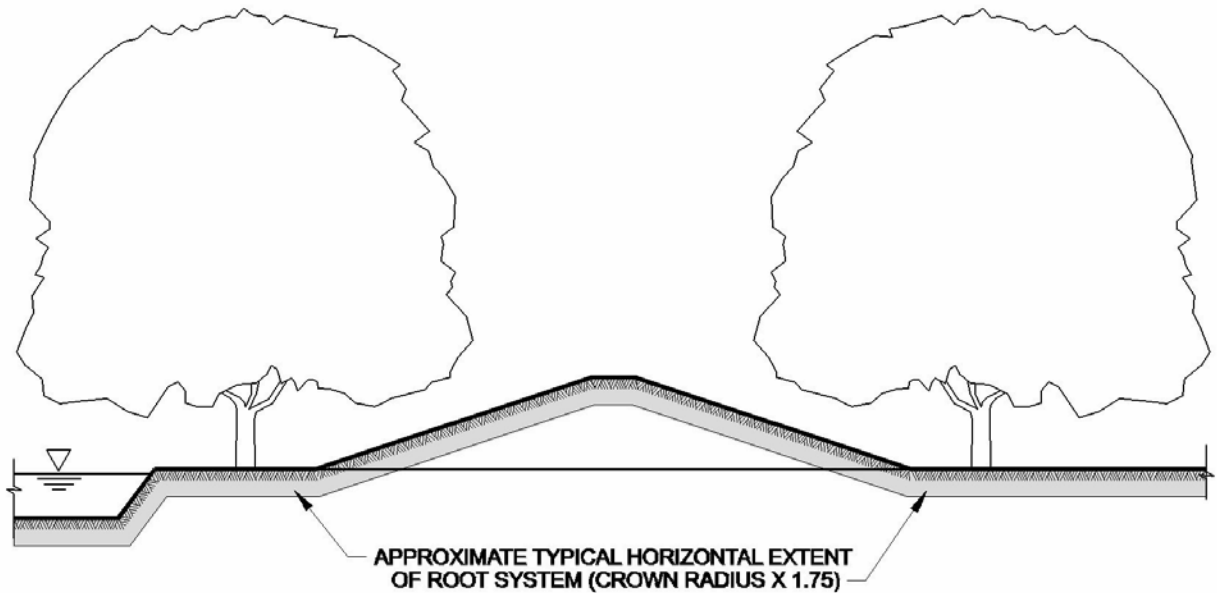
b. TREES (100' TALL, 100' SPREAD) LOCATED AT EDGES OF VEGETATION FREE ZONE (TRUNK CENTER AT 15' FROM LEVEE TOE)

TREES WITH LOW LIMBS OR CROWN, SUCH AS A CONIFEROUS TREE, MUST HAVE TRUNK CENTERLINE SUFFICIENTLY DISTANT FROM THE ZONE THAT NO PART OF THE TREE IS IN THE ZONE. IF THIS TREE WERE TO GROW INTO THE ZONE, IT WOULD HAVE TO BE EITHER PRUNED OR REMOVED

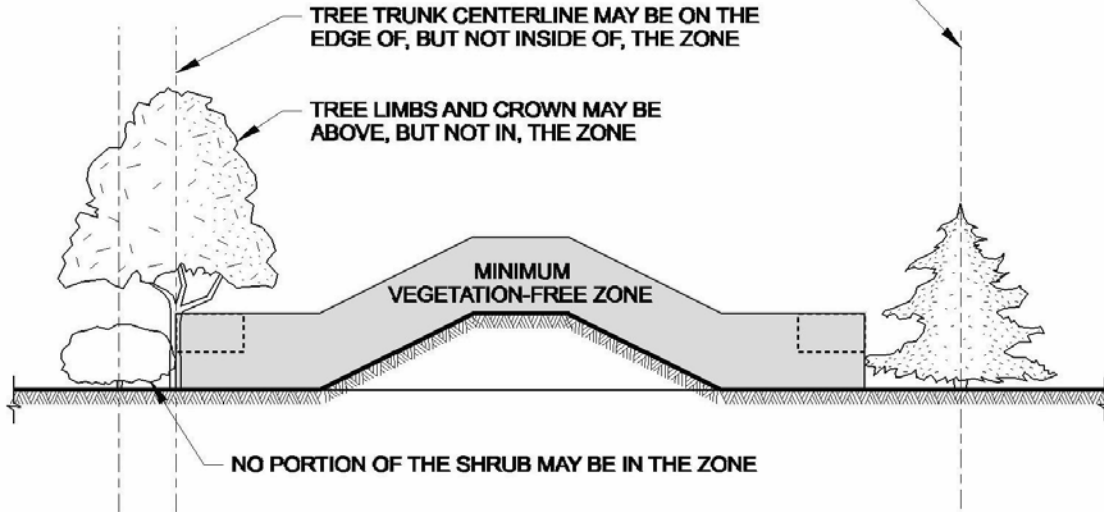
a. MATURE TREES AND SHRUB

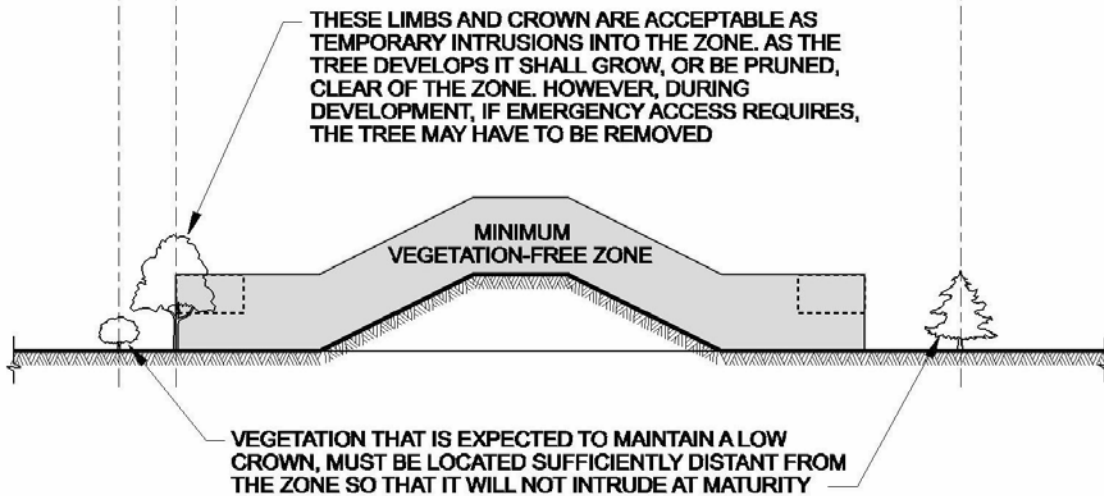
b. NEWLY PLANTED TREES AND SHRUB

NOTE: THE MIRROR IMAGE OF THIS FIGURE WOULD BE EQUALLY CORRECT, REGARDLESS OF WHICH SIDE IS THE RIVERSIDE
